NASA TM-82470

PAST PERFORMANCE ANALYSIS OF HPOTP BEARINGS

By B. N. Bhat and F. J. Dolan
Materials and Processes Laboratory

March 1982

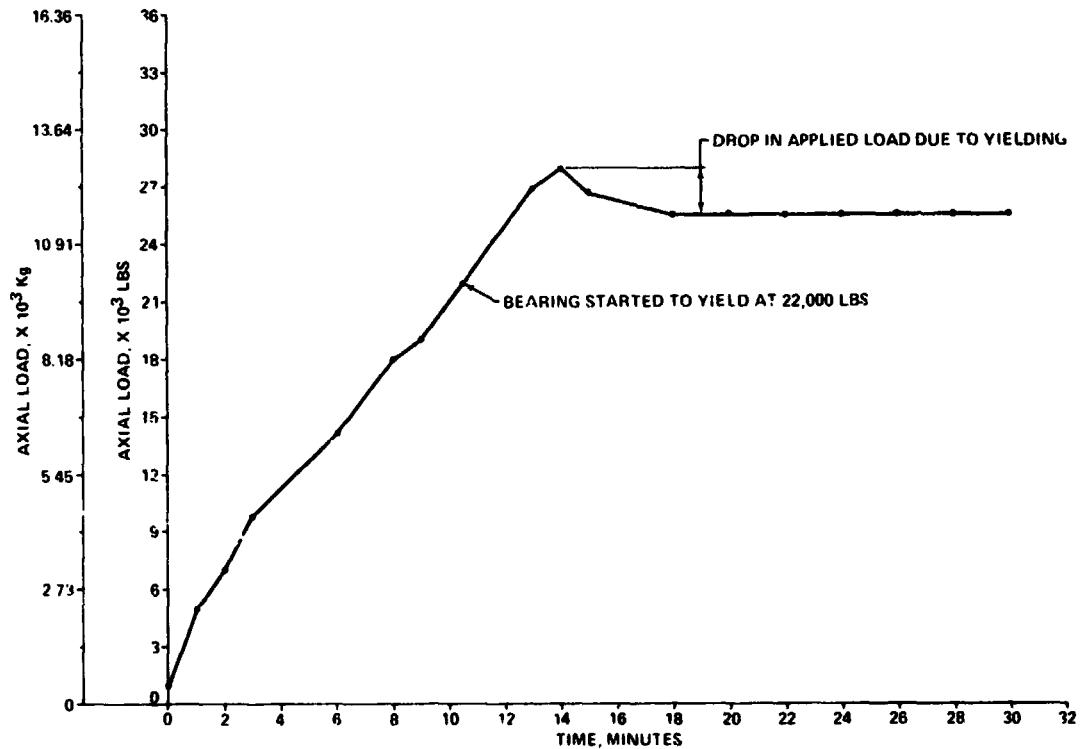
Figure 2. Plot of axial load versus time in laboratory testing of HPOTP bearing S/N 8517929.

Another important result of the laboratory test is that the bearing did not fail catastrophically even under axial loads in excess of 25,000 lb. It is interesting that the bearing can withstand such occasional very high axial loads without catastrophic failure.

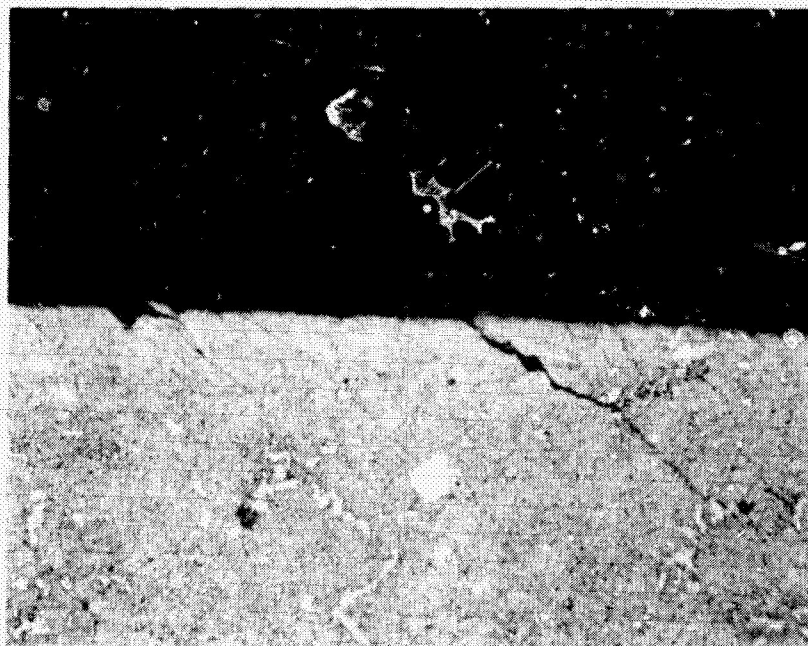
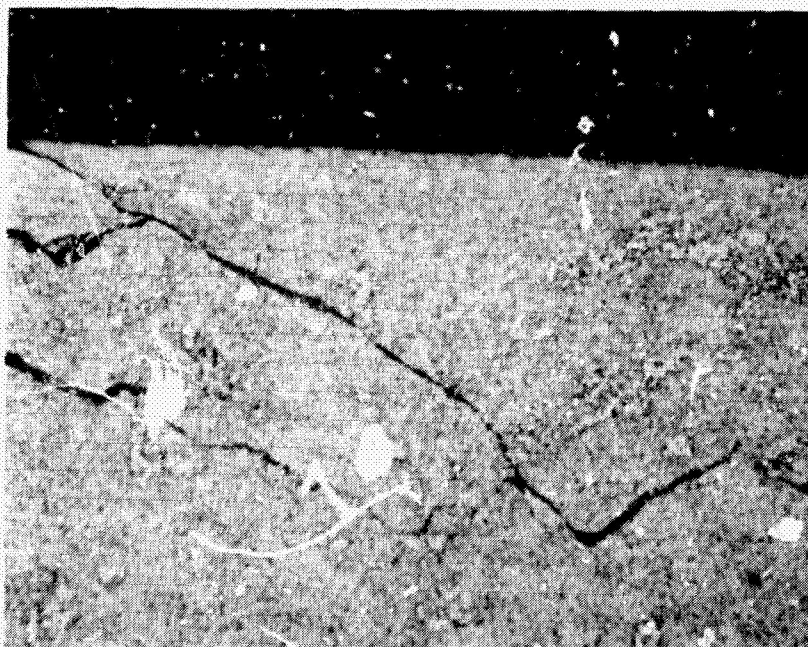
Figure 5. Photomicrographs of inner race sectioned parallel to the wear track. Vilella's reagent. Note the crack origin at surface (A), and also note branching at 90 degrees (B).

Crack branching seems to occur at 90 degrees and at 45 degrees to the surface. This crack pattern may be the result of a high, concentrated load [2]. Surface initiation of cracks suggests that they originated under conditions of poor lubrication or high coefficient of friction [3]. Since the service lives of these races have been relatively short, Hertzian stresses in the races must have been very high. It is difficult to estimate the stresses accurately, however. Battelle has attempted to predict the maximum Hertzian stresses and relate them to depth of cracks assuming that the major cracks are associated with the maximum Hertzian stress [1]. On the basis of this analysis, crack depths of 0.25 mm (0.010 in.) correspond to Hertzian stresses in excess of 4.23 GPA (600 ksi) which is greater than the yield strength of 440C steel [approximately 1.83 GPA (260 ksi)]. Obviously, the raceway would plastically deform under these high stresses. It should be noted that the Battelle report refers to cracks in the inner race as subsurface cracks. This statement appears to be in error, because Battelle evaluated a transverse section of the race taken at 90 degrees to the wear track. In this case, surface initiated cracks could appear as subsurface cracks and erroneously be interpreted as such. Therefore, it appears that bearing races (and balls) should be sectioned parallel to the wear track for the purpose of crack analysis.

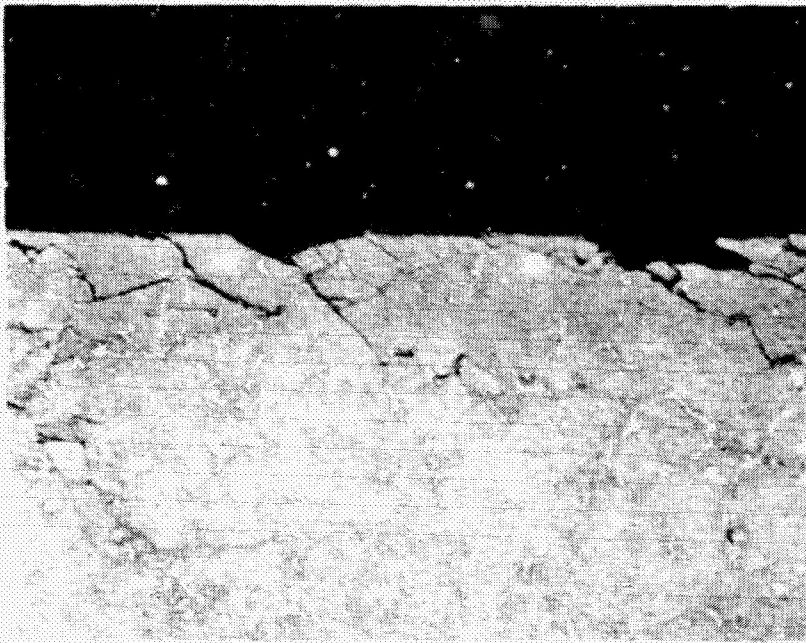
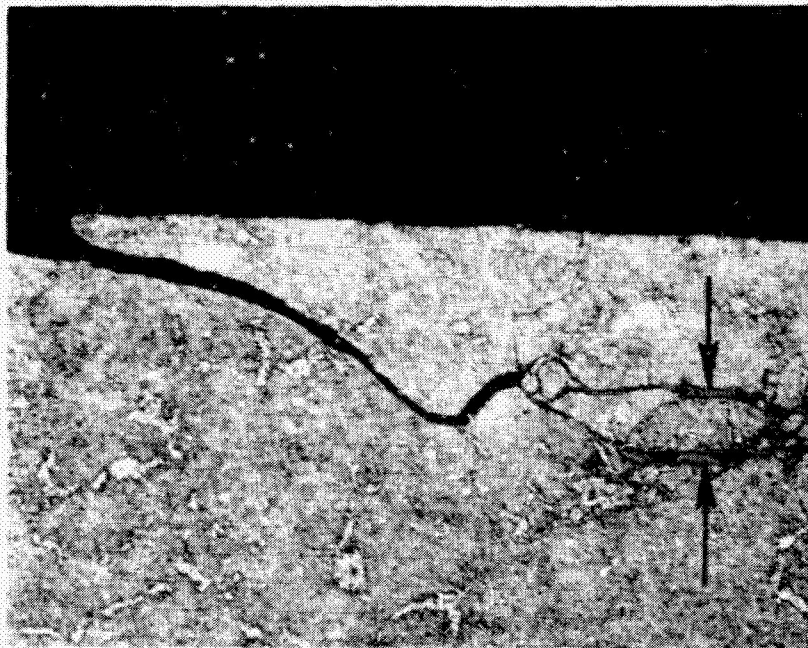
Figure 4. Photomicrographs of inner race sectioned parallel to the wear track. Vilella's reagent. Note the cracking and spalling (A) and oxide in the cracks (B).

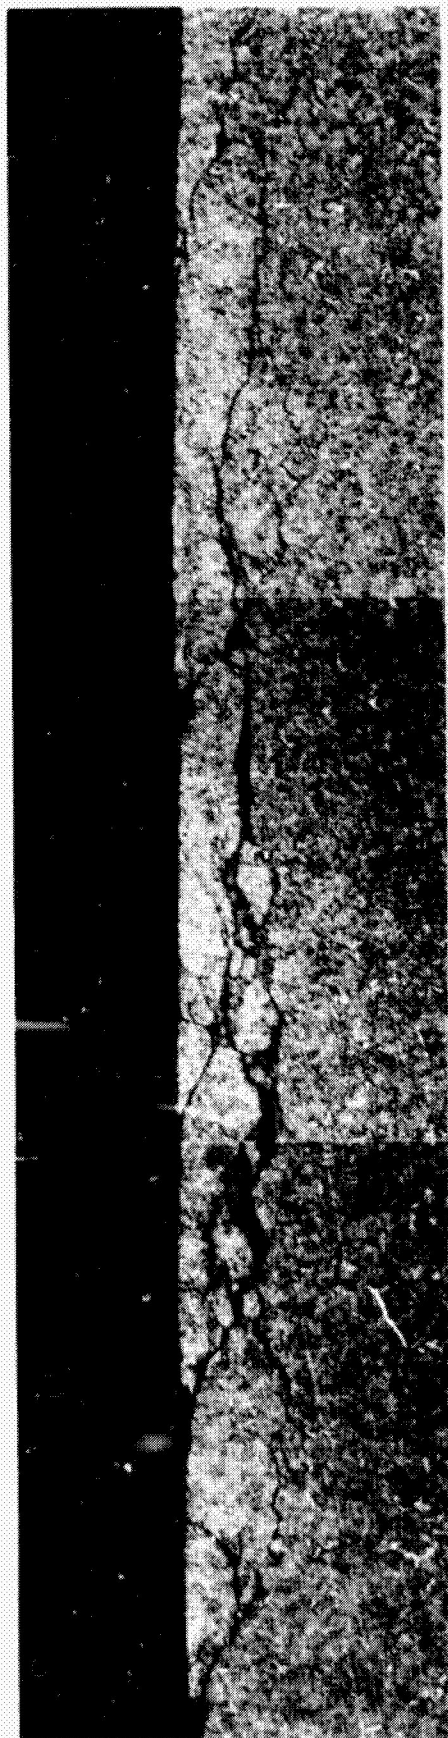
HPOTP bearing S/N 8549531, original mag. 100X.

Figure 5. Photomicrograph of crack pattern in the inner race
of bearing, S/N 8549531.

surface or wear track (Fig. 5). This behavior is not observed in the laboratory test bearing and is in contrast to the propagation pattern in the balls in which cracks seem to propagate at increasing angles. This apparent crack stabilization in the races is not well understood but is very fortunate, because it suggests that the inner race is not likely to fail catastrophically by transverse cracking.

Another interesting feature of cracks in the HPOTP bearing raceway is the presence of oxide. For example, Figure 5 shows oxide films, 1 to 25 μm thick, usually present below the surface, starting at a depth of 0.076 mm (0.003 in.). There is no oxide film present on or near the surface, however. Furthermore, no such oxide film was observed in cracks in HPOTP bearing balls. The presence of an oxide film is indicative of elevated temperatures. Therefore, experiments were conducted to determine the temperature at which oxide layers, similar to the ones observed in the HPOTP bearing races, might form. A piece of 440C steel was heated to 482°C (900°F) and 816°C (1500°F) in air (20 percent O_2 , 79 percent N_2) for 1 hr each. The oxide film formed under these conditions was extremely thin, less than 1 μm . Only surface blackening occurred. At 1316°C (2400°F), however, a very thick, 0.635 mm (0.025 in.) oxide film was obtained in 30 min. The oxide film cracked and flaked off when cooling to room temperature. Figure 14 is a photomicrograph of oxide formed on the metal. The oxide is porous, and the metal-oxide interface is rough. By comparison, the oxide film in the HPOTP inner race does not contain pores (Fig. 7) and has a very smooth interface with the metal. The metal particles in the oxide appear round as opposed to irregularly shaped pieces in Figure 14. These results suggest that the oxide in the bearing races were probably formed at an elevated temperature high enough to melt the oxide. Once molten, the oxide could readily flow and fill up the cracks. An energy dispersive X-ray analysis of the oxide layer showed that the oxide had about the same ratio of iron to chromium (the two major components of 440C steel) as the parent metal. Temperatures in excess of 1400°C (2552°F) would be required to melt $\text{FeO-Cr}_2\text{O}_3$ at approximately 80 percent FeO [6]. However, the nature of the oxides formed at high oxygen pressures present in the turbopump is not known. Chromium is known to form high oxides (e.g., CrO_2 , CrO_3) at low temperatures and high oxygen pressures [7], but such information is lacking for iron. Handbook of Physics and Chemistry reports a melting point of 300°C

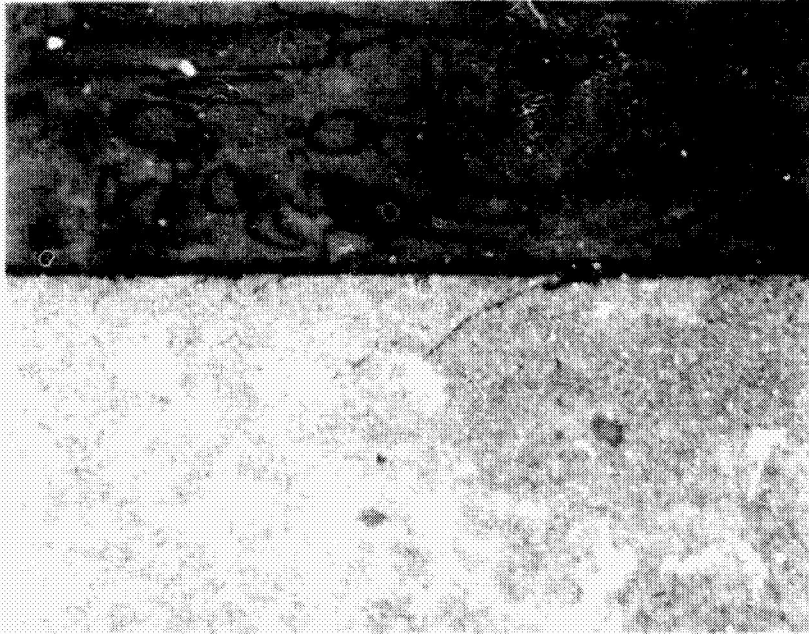
HPOTP bearing S/N 8549531, original mag. 400X.

Figure 6. Photomicrograph of outer race, sectioned parallel to the wear track. Note surface crack initiation. Crack depth approximately 0.025 mm (0.001 in.).

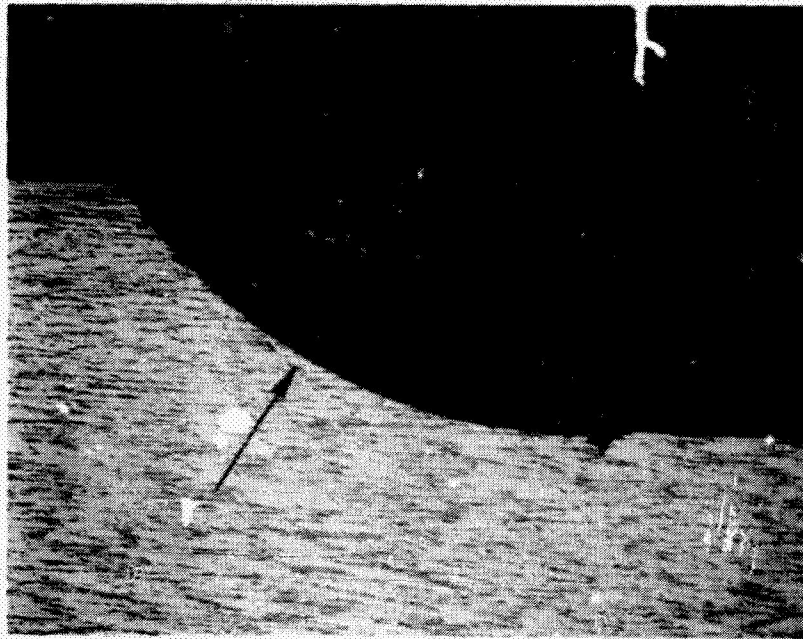
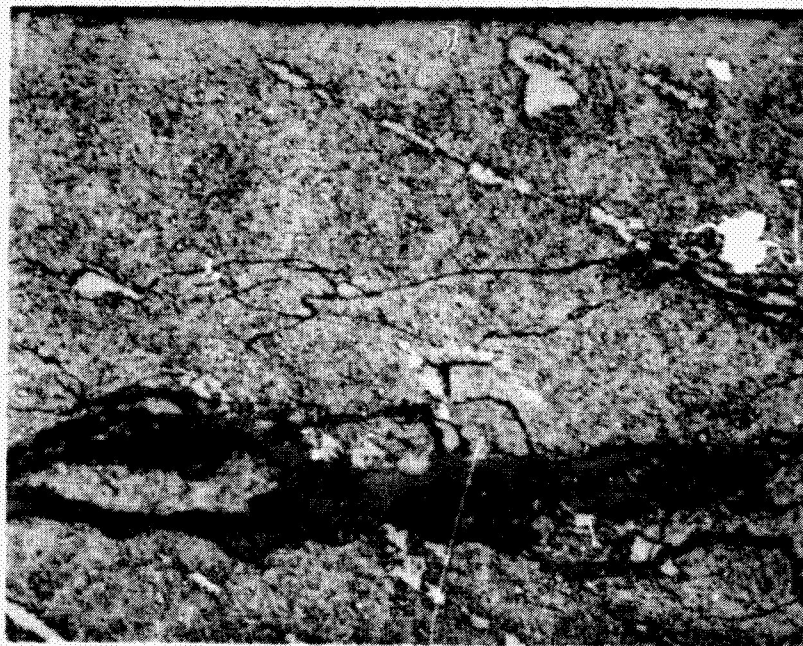
S N 8517824	Crack pattern very similar to that of S N 8549531 described above. Oxide film in cracks is thicker, up to 25 μ m (Fig. 7). Rounded metal particles present in the oxide.	No spalls present. Not examined metallographically.	Not examined metallographically.
S N 8517929	Severe shoulder damage. Prominent wear track located at the shoulder. Numerous cracks and small spalls present in the wear track. The cracks appear to originate at the surface, starting at small angles and propagating inwards at increasing angles. Deformed metal is evident up to a depth of 0.1 mm (0.004 in.). Deepest crack approximately 0.03 mm (0.0012 in.) deep. No crack branching was observed. (Figs. 9, 10, and 11, macrograph in Fig. 8)	No visible spalls. Showed very shallow, up to 0.025 mm (0.001 in.), surface cracks starting at the surface at small angles. Angles increase with depth (Fig. 11).	No visible spalls. Showed very shallow, up to 0.008 mm (0.0003 in.), surface cracks, starting at small angles (Fig. 13).

Figure 7. Photomacrograph (A) and photomicrograph (B) of inner race sectioned perpendicular to the wear track. No visible shoulder damage. Location of major spalls shown by arrow in A. Note the thick oxide layer filling the crack in B.

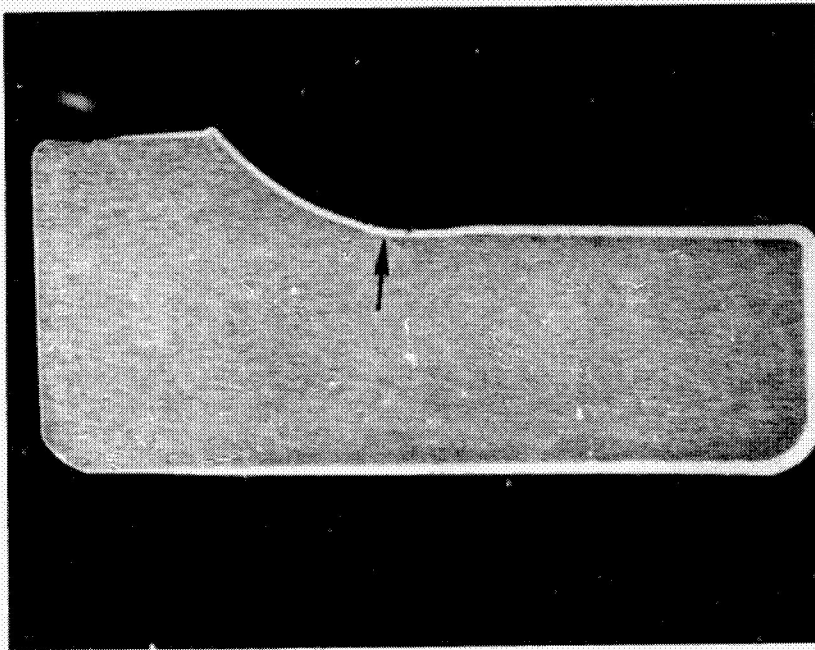
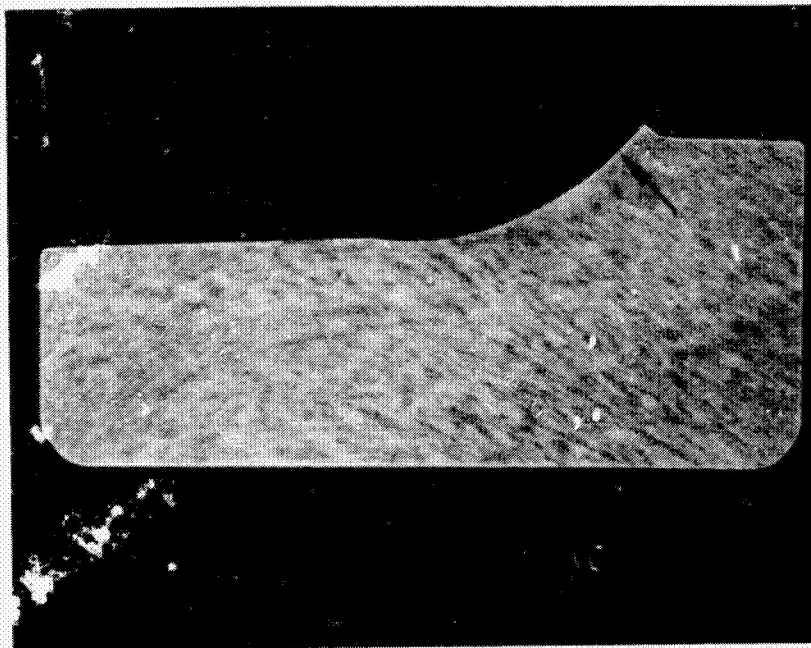
Figure 3. Photomicrographs of inner race sectioned perpendicular to the wear track. (A) F20TP 9008, engine 2004 nickel plated. (B) laboratory test.

Note the shoulder damage due to high axial loads.
Arrows show the areas where major cracking occurred.

The most interesting feature of the inner race failure is the location of cracks and spalls. In the bearing tested under high axial loads (bearing S/N 8517929) areas of major cracking are located at the shoulder (Fig. 8, B). The shoulder is deformed under high axial loads. In the HPOTP bearing S/N 8549521, however, areas of major cracks and spalls are located away from the shoulder (Fig. 8, A), close to the lowest point on the raceway. In addition, there is evidence of shoulder damage. In the case of bearing S/N 8517824 (Fig. 7), areas of major cracks and spalls are about halfway in between the shoulder and the bottom of the raceway. There is no evidence of shoulder damage on this race suggesting that this bearing had not experienced

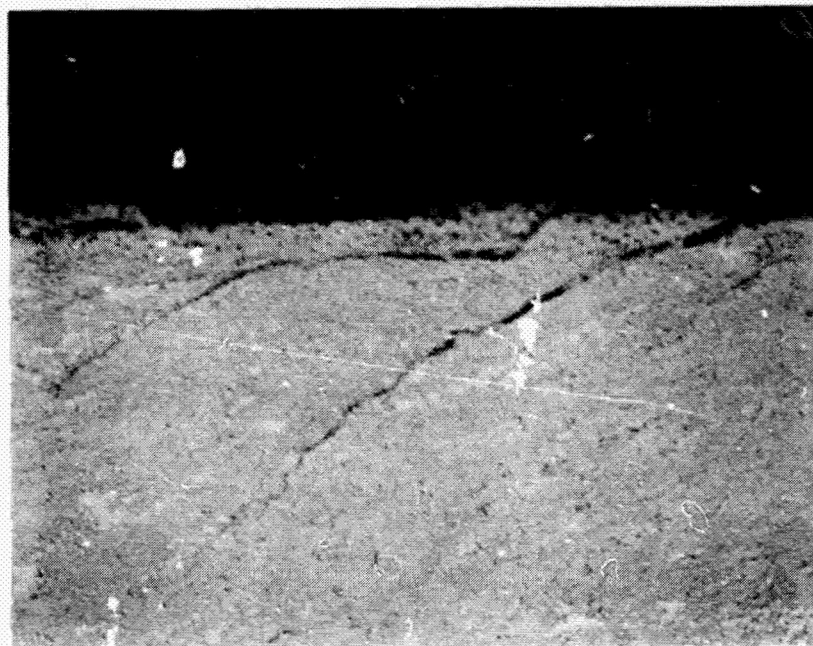
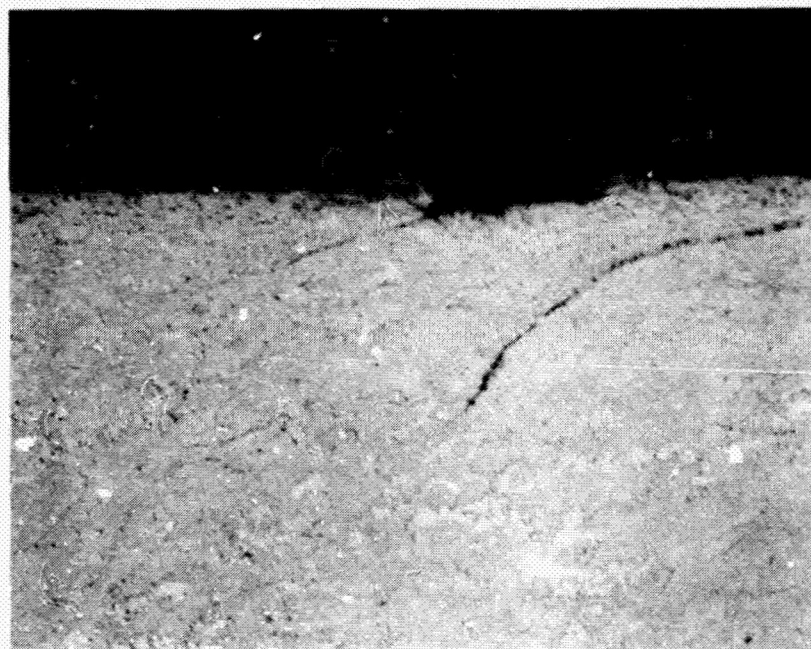
Figure 9. Photomicrographs of inner race sectioned parallel to the wear track. Vilella's reagent. Note the crack origin at the surface. The cracks start at small angles to the surface and propagate inward at increasing angles.

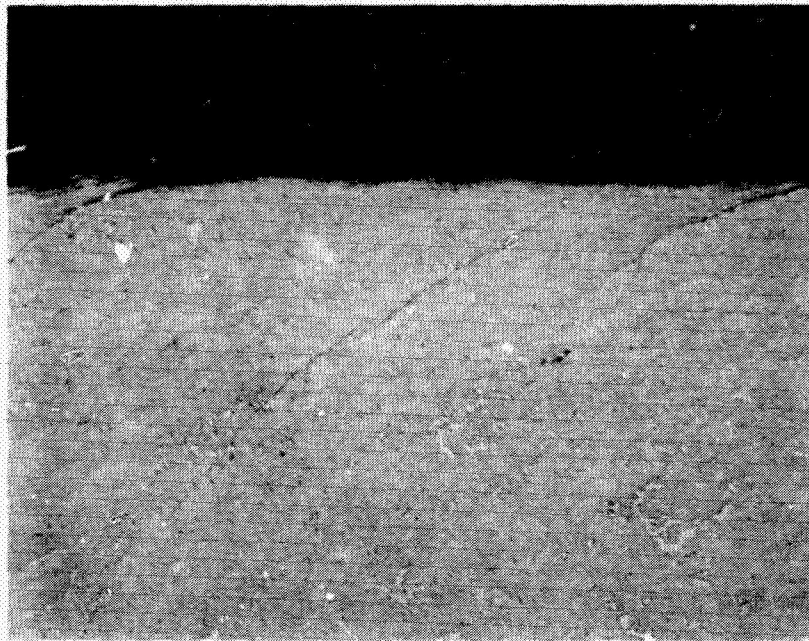
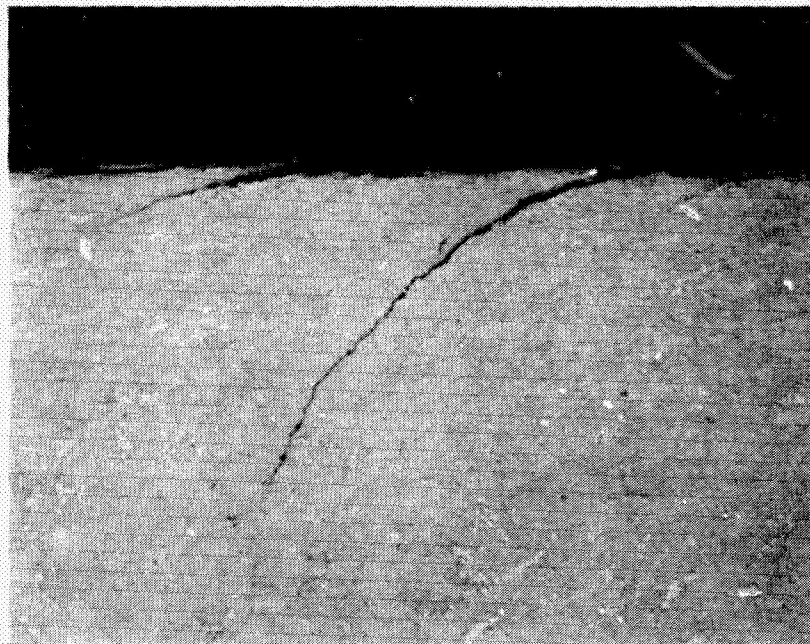
Figure 10. Photomicrographs of inner race sectioned parallel to the wear track. Note the low angles of crack initiation. Deformed metal is evident in the first few thousandths of an inch.

A comparison of crack configuration of the HPOTP bearing tested under heavy axial loads is also given in Table 6. Main differences are (1) lack of branching, (2) presence of a deformed metal layer, and (3) absence of an oxide film in cracks. No major spalls were observed. The reasons for these differences are not well understood and can only be speculative. One possible reason is that the HPOTP bearings were run at a high speed (about 30,000 rpm versus 10 rpm in the lab test). Other factors could be the total number of cycles of stress repetition and the temperature. In addition, 440C steel is likely to be more brittle at cryogenic temperatures than at room temperature. Still another possibility is the transformation of retained austenite. Under stress and thermal cycles of HPOTP operation, retained austenite could transform into brittle, untempered martensite or bainite which could fracture in a brittle manner.

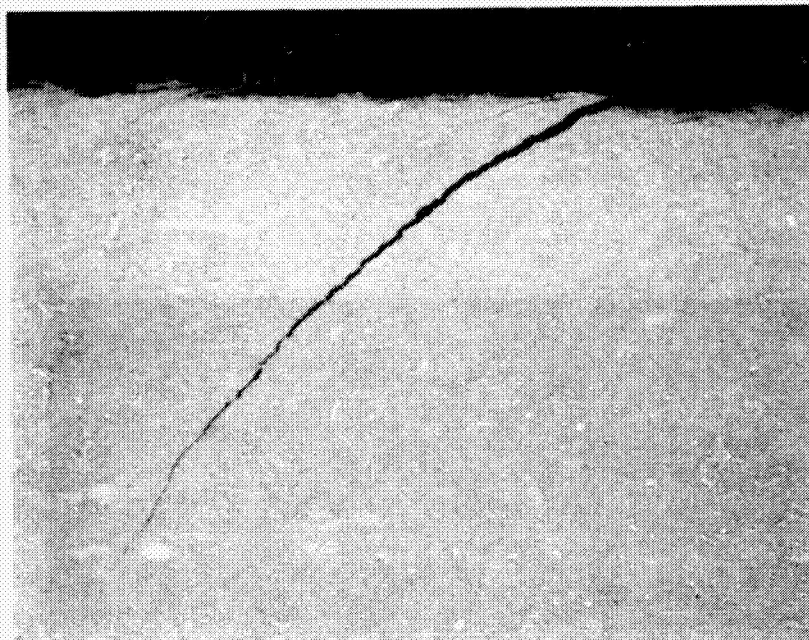
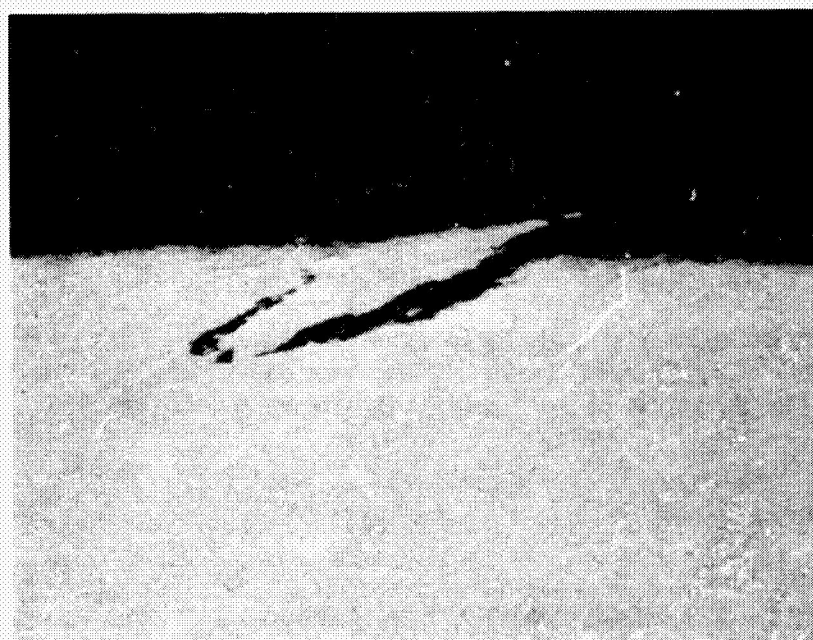
Figure 11. Photomicrograph of a deep crack (A) and an incipient spall (B) on inner race.

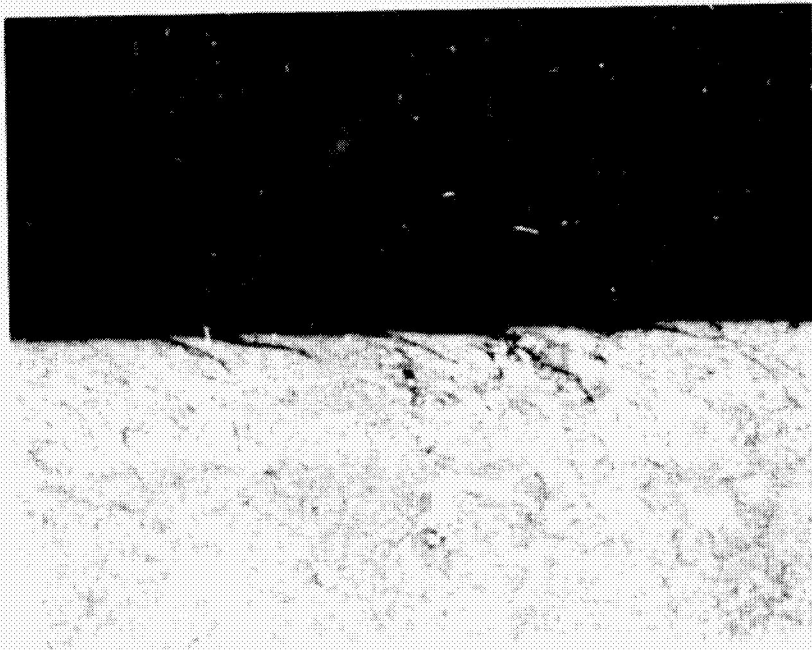
Bearing S/N 8517929, original mag. 400X.

Figure 12. Photomicrograph of outer race sectioned parallel to wear track.
Tested at high axial loads. Note surface crack initiation.
Crack depth approximately 0.025 mm (0.001 in.).

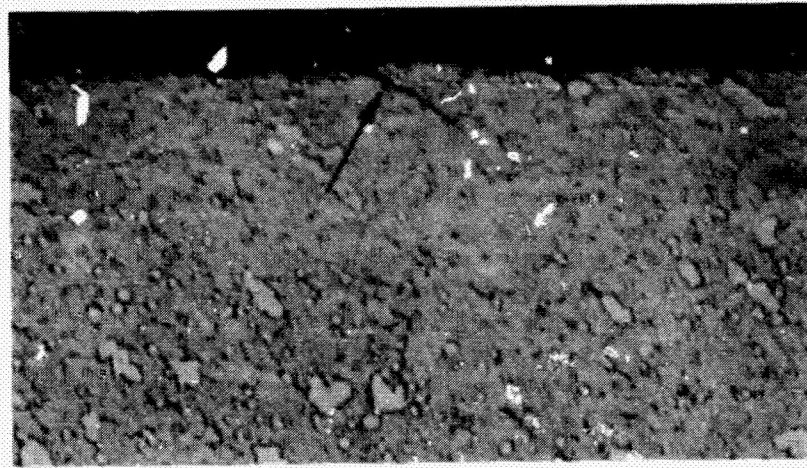
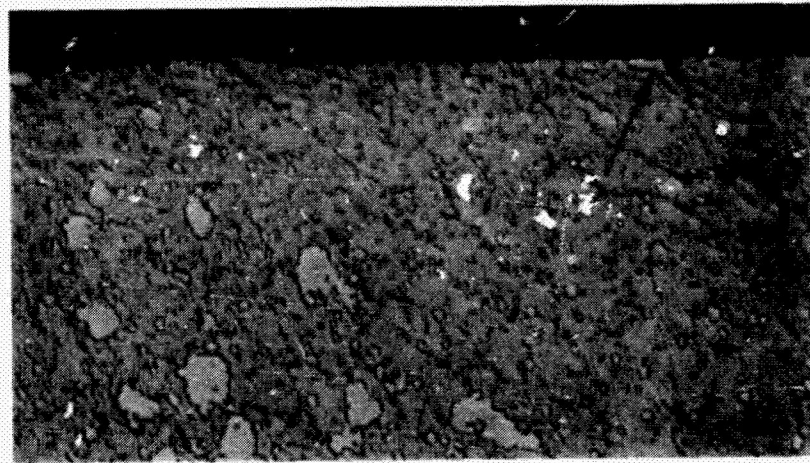
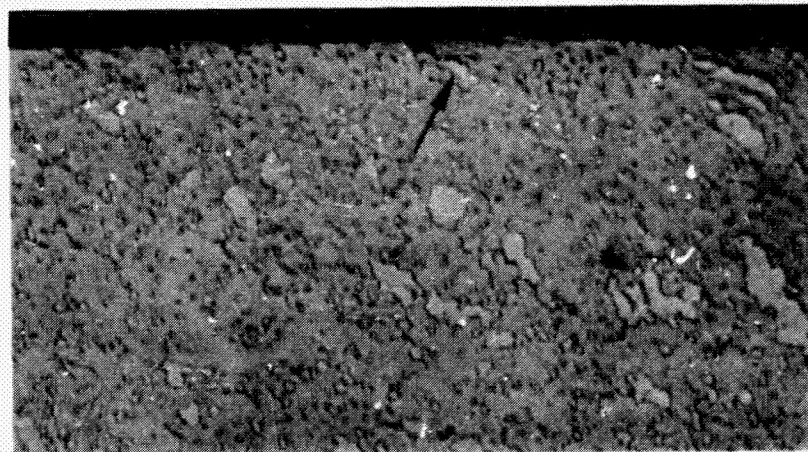
Figure 13. Photomicrographs of cracks in bearing ball. Note the surface cracks and carbides associated with crack origin (arrows). Crack depth approximately 0.008 mm (0.0003 in.).

There were very few cracks present in the balls or the outer race in the laboratory test bearing. The cracks present were very shallow, less than 0.025 mm (0.001 in.) deep. Many of these cracks seemed to originate at carbides (Fig. 1C). Overall, it appears that under conditions of very high axial loads and practically zero radial loads, the inner race is damaged much more than either the balls or the outer race. This conclusion is also supported by the general experience of the bearing industry where inner races are usually observed to fail first by fatigue [4]. In HPOTP bearings used in engine tests, however, it is claimed that the balls fail before the inner race [5]. The result of the high axial load test conducted at M&P Laboratory does not support this claim.

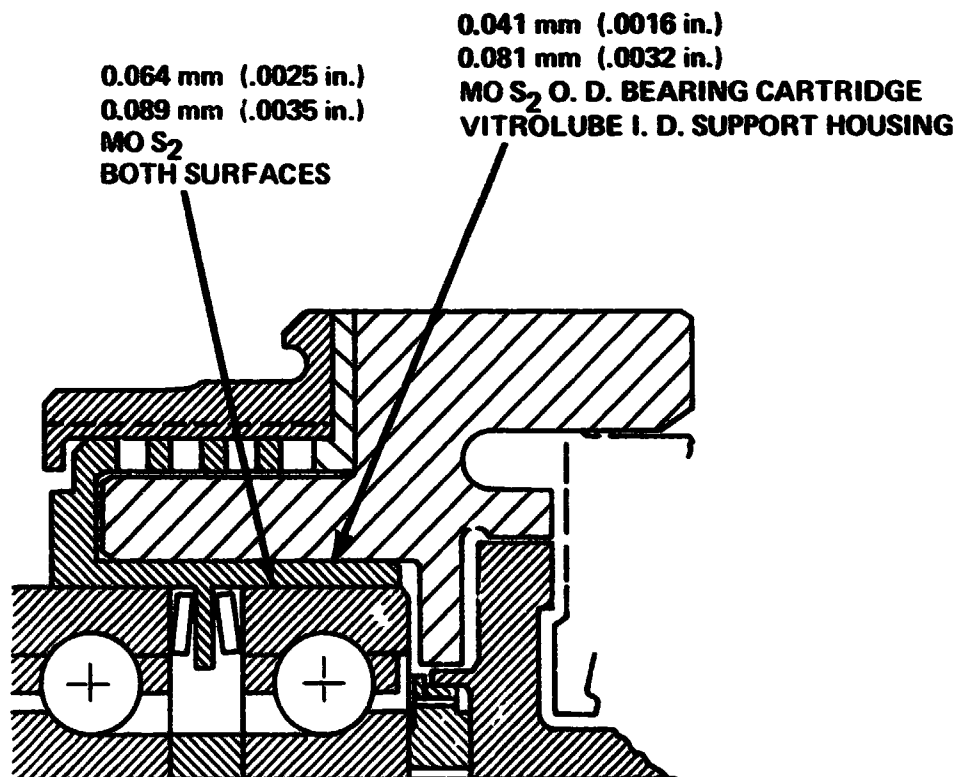
Clearances in the HPOTP turbine bearing and cartridge area are shown in Figure 17. The total diametral clearance between the turbine bearing outer races and the cartridge is 0.063 to 0.089 mm (0.0025 to 0.0035 in.). The total diametral clearance between the bearing cartridge and the support housing is 0.041 to 0.081 mm (0.0016 to 0.0032 in.). An axial hangup can result if the clearances listed above are reduced to zero by some means. Actually three different types of hangup can occur (1) one or both bearings can hang up in the cartridge, (2) the cartridge can hang up in the support housing, or (3) both types of hangup can occur simultaneously. This situation could develop because of the following reasons:

Figure 17. Bearing clearances in HPOTP bearings No. 3 and 4.

operating at about 500°C (932°F). These temperature differences cause thermal stresses which can result in distortion of the housing. The housing tends to become egg shaped and cartridge clearance tends to be reduced.

2) The bearing outer race outside diameter becomes enlarged as a result of hoop stresses resulting from bearing preload and centrifugal ball loads and as a result, outer race clearances are expected to be reduced.

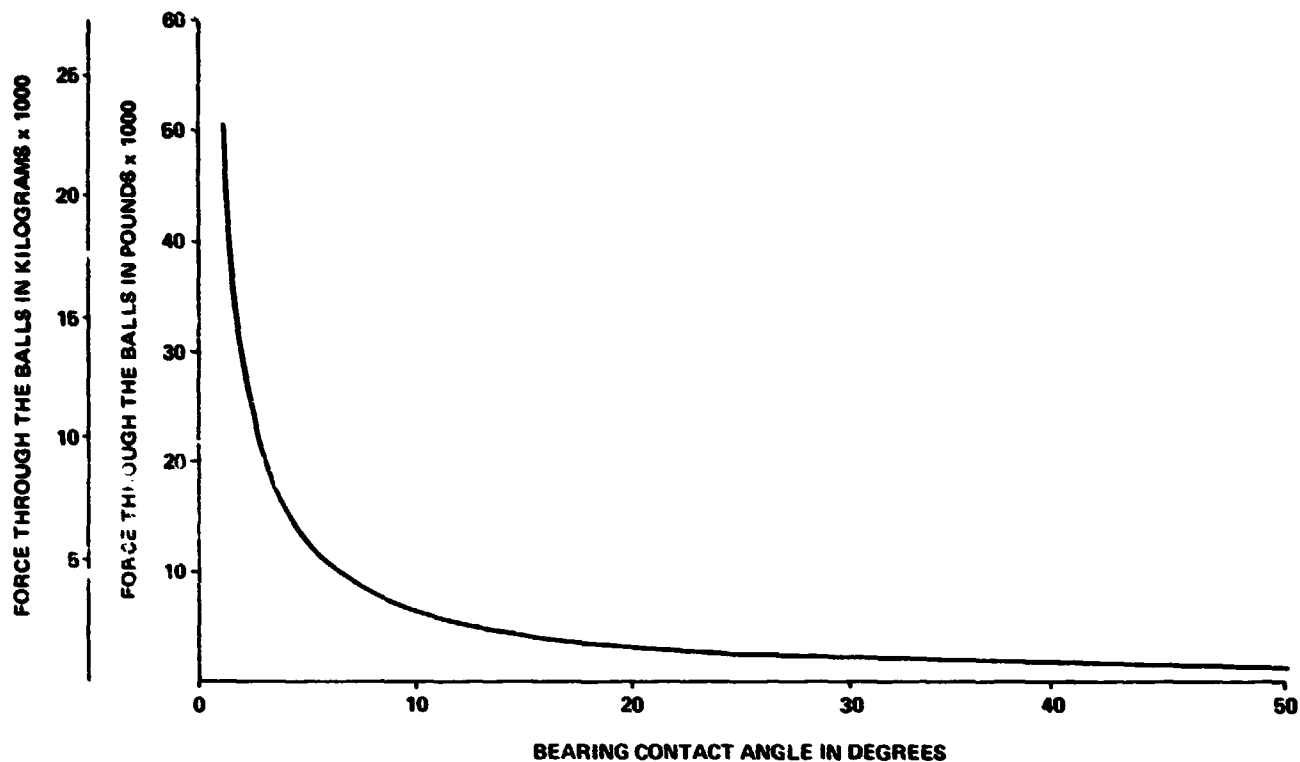
Bearing internal clearances and forces through the balls can also change with contact angle. Figure 18 is a plot of forces through the balls as a function of bearing contact angle. A loss of bearing internal clearance results in a decrease in contact angle and an increase in reactive force through the balls, which is equivalent to an increase in axial load on the bearing. This, in turn, will cause increased heat generation which serves to make the situation worse. The problem is more pronounced in a 15 degree angular contact bearing than a 25 degree angular contact bearing, as illustrated in Figure 18 where the 15 degree contact angle is closer to the "knee" of the reactive force curve than the 25 degree contact angle. It should be noted that the turbine end bearings (Nos. 3 and 4) have a 15 degree contact angle and all other HPOTP and even HPFTP bearings have a 25 degree contact angle. Therefore, it appears that Nos. 3 and 4 bearings may be more susceptible to high bearing reactive forces and associated thermal problems than the other SSME turbopump bearings.

Figure 18. Bearing preload reactive force through the balls as a function of bearing contact angle for a constant 500 kg (1100 lb) preload.

In extreme cases bearing internal clearances may become zero or even negative. As this situation develops during HPOTP operation, the preload reactive force across the balls becomes very high and heat generation goes up causing bearing temperatures to rise. At some point, the temperature of the balls and inner race becomes sufficiently elevated that the lox cooling fluid at their surfaces exceeds its saturation temperature, and gas bubbles are formed at the hot surfaces causing the heat transfer film coefficient to decrease drastically. With a reduced heat transfer film coefficient the bearing temperature will rise further. Higher temperatures are expected to improve the rate of heat transfer until the heat dissipated is again equal to the heat generated; hence, a new stable but elevated temperature operating condition may be attained. Hence, it appears that the HPOTP Nos. 3 and 4 bearings may be capable of operating in a bistable thermal mode wherein under moderate heat generation conditions cooling is accomplished by a liquid (lox) and bearing operating temperatures are generally low, about -160°C (-256°F). Under severe operating conditions high bearing temperatures are believed to cause a transition to gas (gox) cooling. At this point bearing temperatures index upwards [to estimated $+250^{\circ}\text{C}$ (482°F) or more, based on ball surface discoloration] as a result of a drastically reduced heat transfer film coefficient. This high temperature operating mode appears to be at least partially the result of this bearing's 15 degree contact angle and lack of sufficient internal diametral clearance. It should be noted that while the bearing is operating at the high temperature operating mode the bearing and cartridge would be locked up or at least free motion would be severely restricted and any axial movement of the shaft would overload the turbine end bearings.
